Debris/Ice/TPS Assessment and Integrated Photographic Analysis of Shuttle Mission STS-65

*Gregory N. Katnik, Barry C. Bowen, J. Bradley Davis,
Vehicle Engineering/Mechanical System Division/ET Section,
Kennedy Space Center, Florida*

July 8, 1994

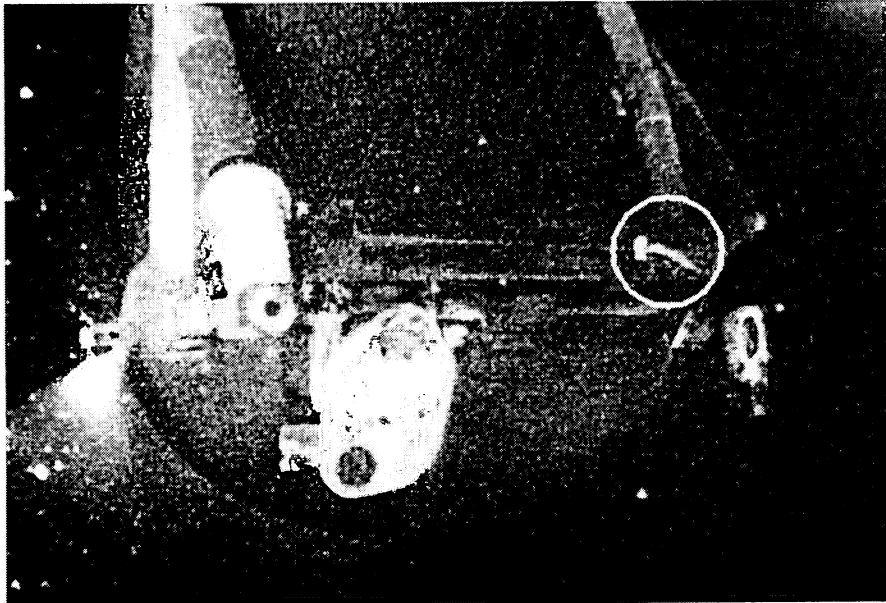
Figure 7 ET Separation Debris from Onboard Camera

During ET separation, a large piece of debris was noted on the right side of the tank from the 16mm onboard camera. This debris is depicted in Figure 7.

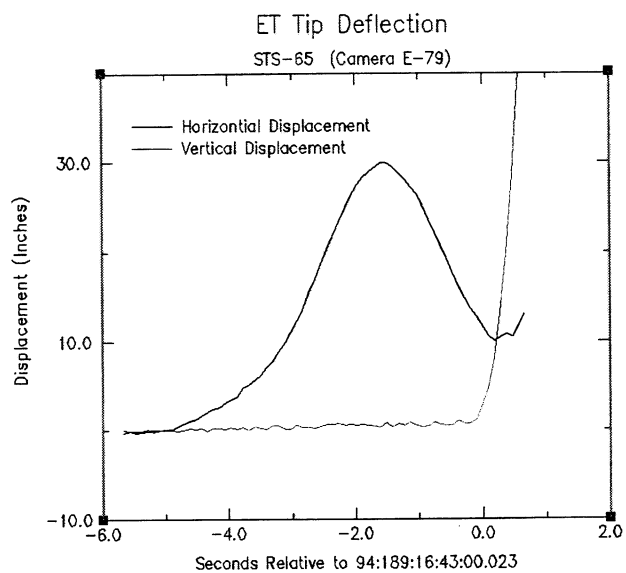
Figure 8 ET Tip Deflection

Maximum ET tip deflection for this mission was determined to be approximately 30 inches. Figure 8 is a data plot showing the measured motion of the ET tip in both the horizontal and vertical directions. A positive horizontal displacement represents motion in the -Z direction. These data were derived from film camera E-79.
